# BULLETIN

## *PRODUCT SERVICES - Schaumburg*

Subject: MSR2000 and MSF5000 Ferro Resonant power supplies,  
TPN1185A, TPN1218A, TPN1184A, TPN1192A, TPN1226A, TPN1227A

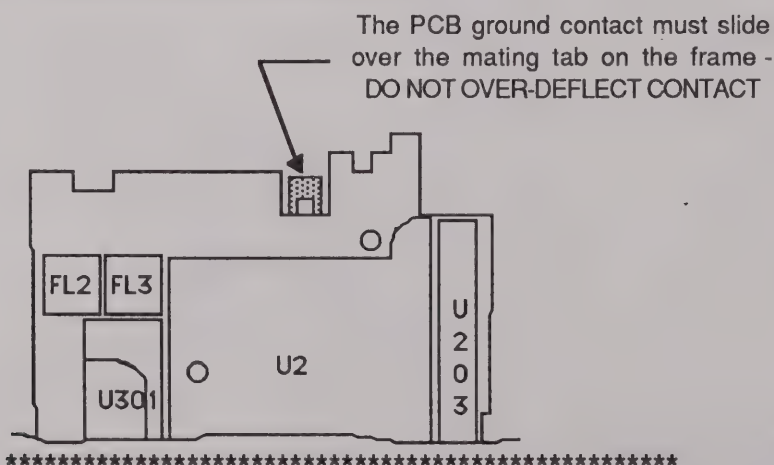
All H33 and H43 model Saber radios have a PC board ground contact (P/N 3905889R01) which makes electrical contact to a tab on the frame under the control top panel. This contact can fracture if excessive force is applied to it during insertion of the PC board assembly into the frame assembly. If abnormal resistance is observed during insertion, check the alignment of the PC board slots and the frame tabs to ensure they are mating properly.

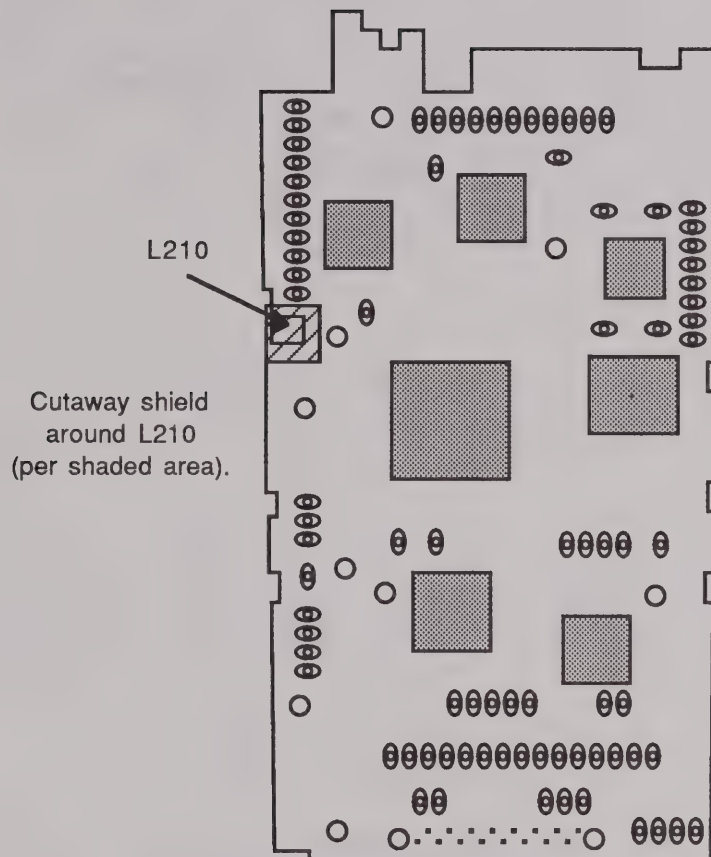
### DIAGRAM C

Some secure radios were shipped with a slot in the back shield to prevent interference with L210 on the main printed circuit board as shown in the diagram below. If the back shield on these radios must be replaced then the new back shield must be cut away in the area around the inductor as shown below. On newer PC boards L210 is not positioned close to the edge and no modifications are necessary. See diagram C.

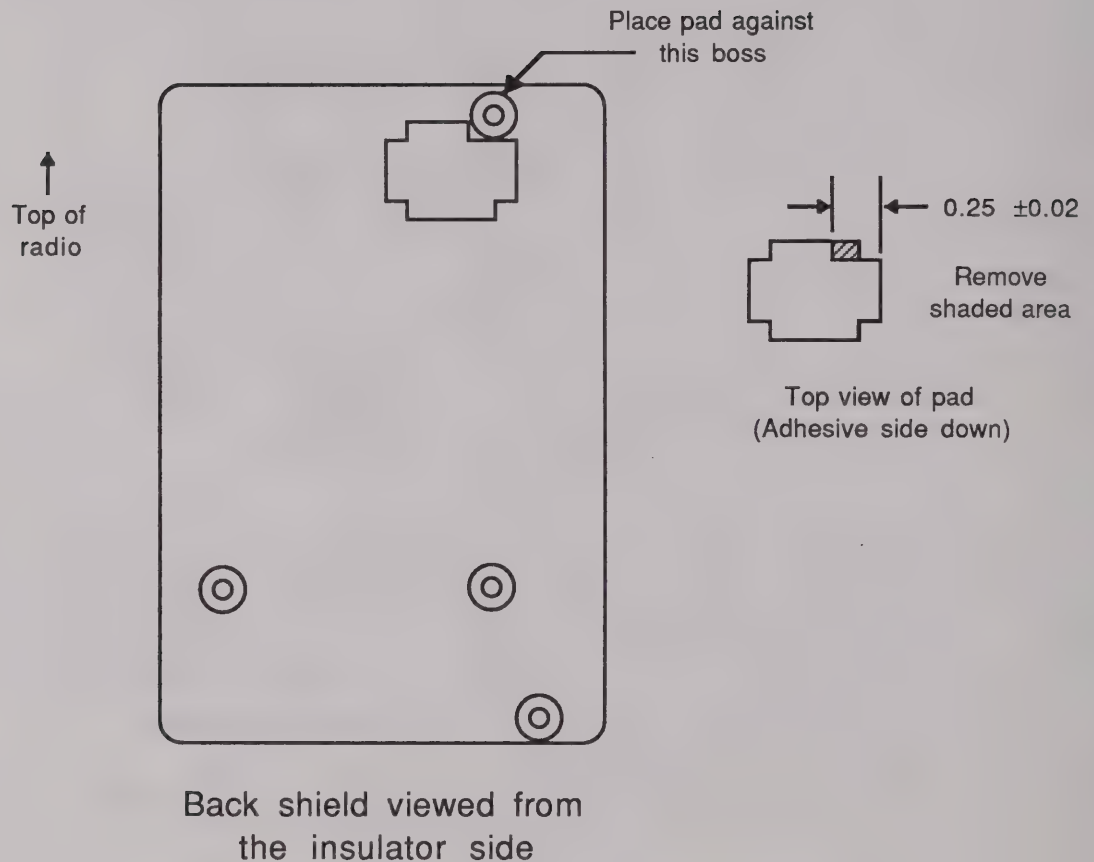
### DIAGRAM D

All H34 and H44 model Saber radios contain a receiver front end module (U2). The two guide pins on this module may fail when the unit is subjected to high levels of shock in a unique orientation. Additional protection can be provided by adding a pad to the back shield above the module guide pins as shown in the diagram D. The pad used is P/N 7505934Q01 modified as shown diagram D.

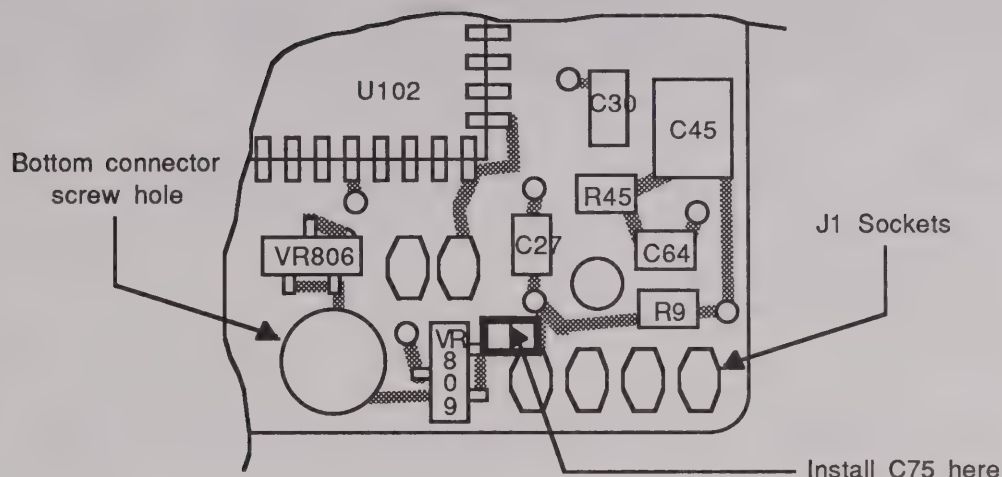
### DIAGRAM E

An issue has been identified that affects a small number of UHF Saber portables. Transmitter deviation has been found to be very low in these radios when held very close to the face in a normal position for use. This is the result of RF desensitization causing a reduction in the microphone output to the audio IC. An RF decoupling capacitor has been added on all current and future production radios; this information is detailed below and in diagram **E**.

Bottom right corner of  
main PCB as viewed  
from back (IC-side)

Added: C75 100 pF, 5% chip capacitor  
Motorola part number 2160520G01

Installation of the capacitor is between socket J1-4 and the ground (2 lead) side of VR809 on the main PC board (see diagram). This component should be installed on any UHF radios not having the component from the factory; when in for any service requiring removal of the radio from the housing. Note as above, most radios will exhibit no problem.

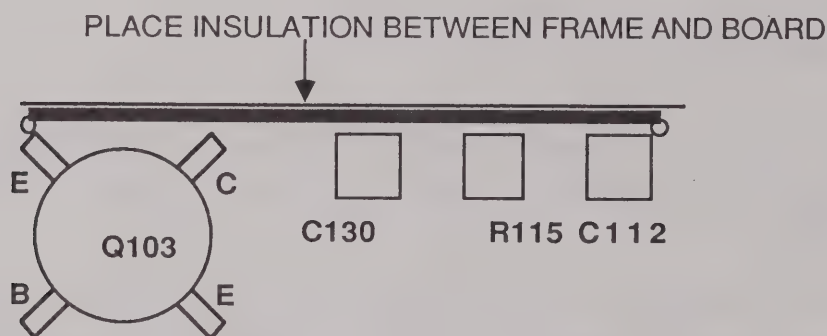
**5. Noisy Tx signal:** This may occur on some high power UHF boards when an unusually large pressure is applied to the PTT switch. This is the result of momentary contact between the frame and a ground to ground jumper from the emitter of Q103 to either R115 or C112. In most cases, the problem can be alleviated by slipping a piece of insulating tape (Part NO. 1405209I02) between the frame and the rf board (as shown on the diagram). It may be necessary, however, to remove the rf board in order to properly insulate the frame. (Radios shipped after April 1988 will not have the jumper or will be properly insulated prior to shipment). On all other radios this problem may be the result of loose or missing screws, mangled shields, or anything else that could cause some type of metal on metal movement.

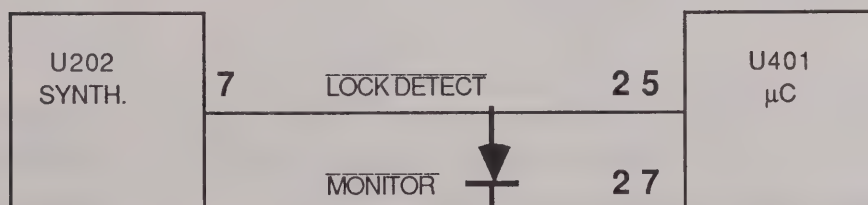
**10. Radio will not clone:** On earlier versions (UHF and VHF models built prior to August 7, 1987 and units after that with controllers date coded prior to 8733) a hardware fix is required to prevent a condition that occurs when the master radio does not initiate the cloning procedure due to an incorrect error message in its self diagnostics. Diode P/N 4805494Q04 or (48082363E03) must be added from the LOCK DETECT line to the MONITOR line on the controller, to correct this condition. (See diagram below for modification details).
